UTAH 3809 COMPLIANCE INSPECTION REPORT

Operator(s): Good Earth Minerals LLC (CII 5 and 6 claims)

Project name: GEM Mine Project

Location: T43S R17W Sec 24 NE1/4NW1/4

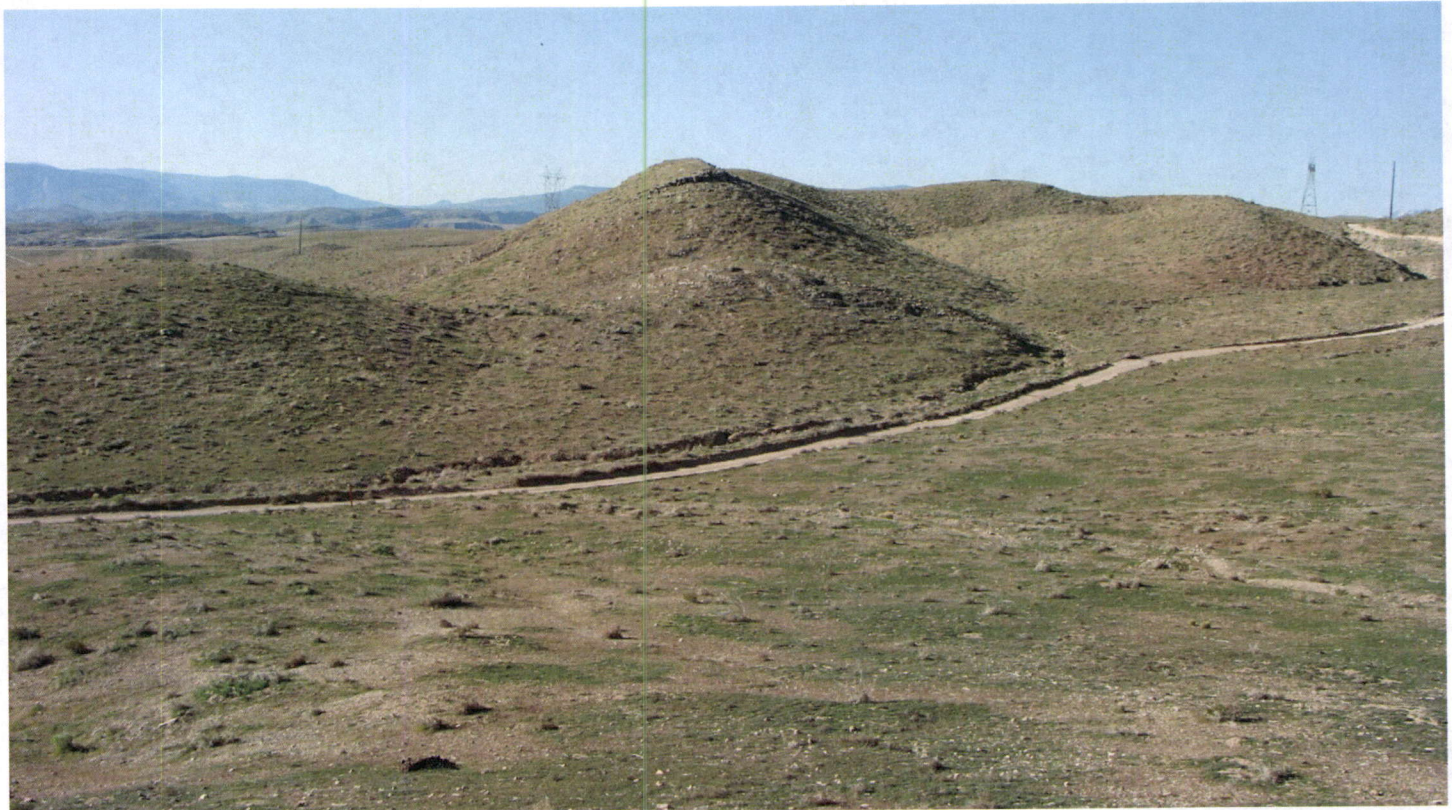
Overview looking south, showing the ridge to be mined.

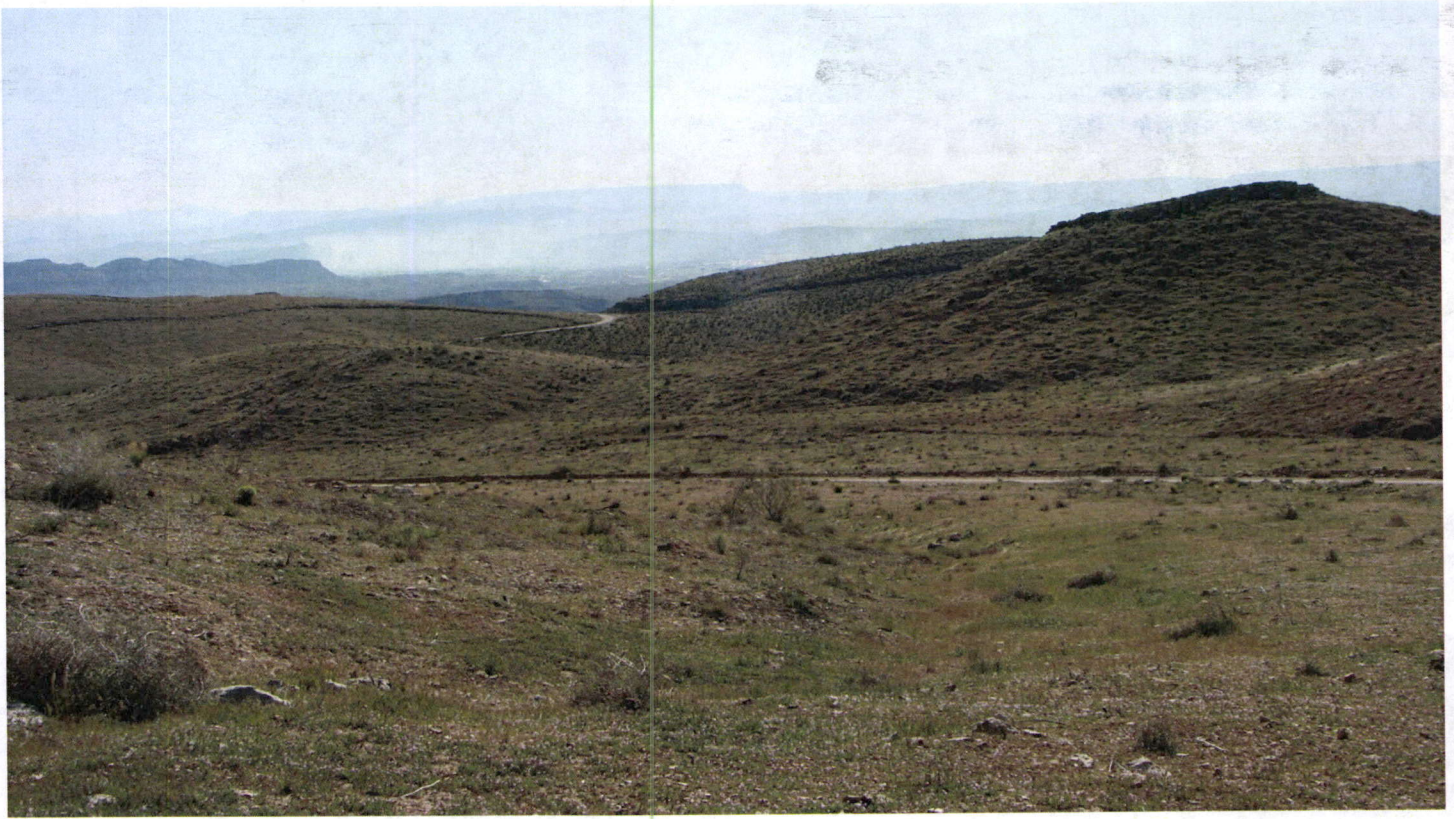
Overview looking southeast, showing the ridge to be mined consisting of two hills/buttes. The limestone cap on the right butte is visible. Note dozer trench visible on the smaller hill on the left.

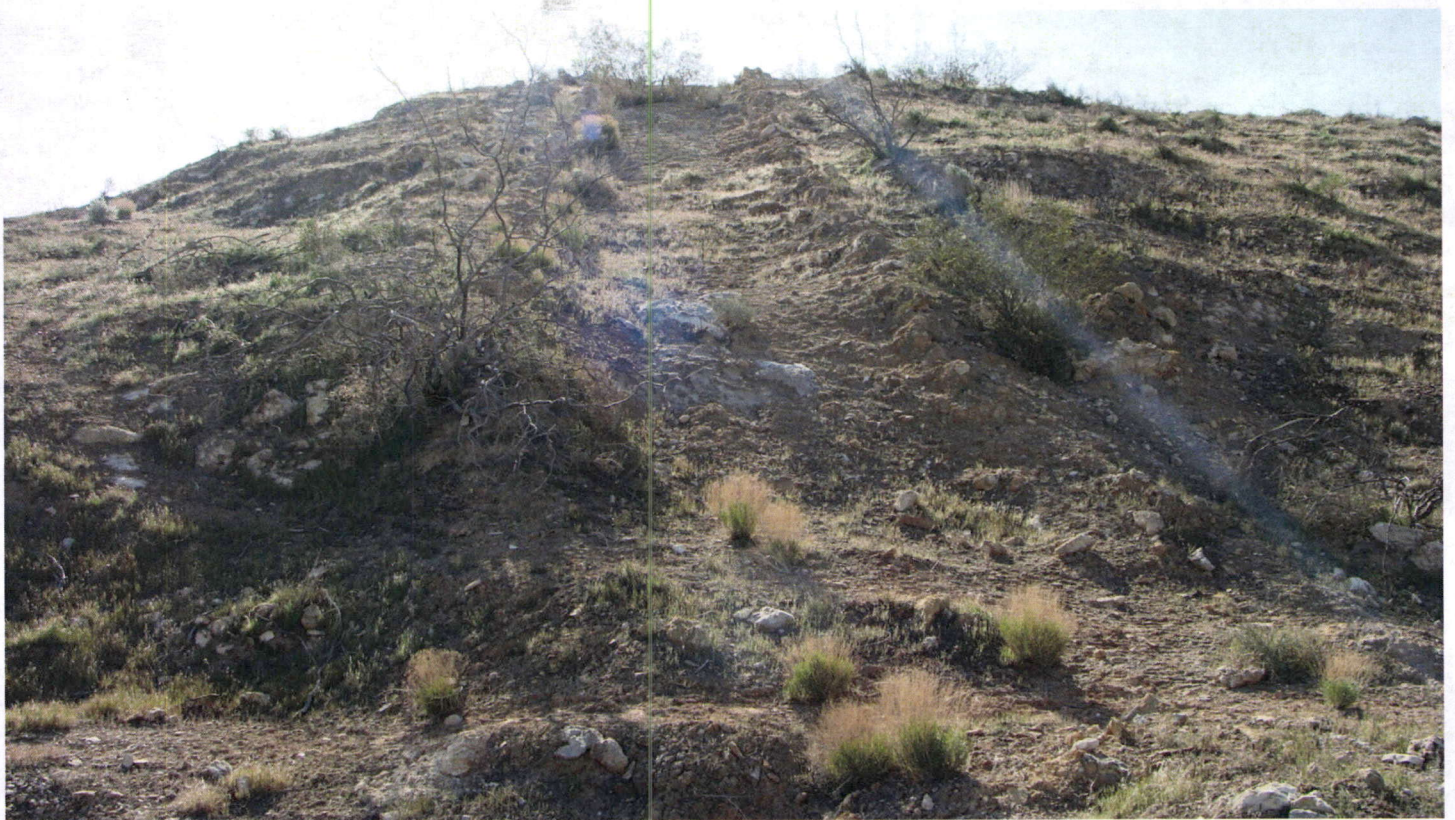
View of dozer trench cut to expose gypsum, showing thin 0.5 to 2 ft thick soil cover. Area was burned during 2006 Jarvis fire. Matchweed, Mormon Tea, creosote bush, Anderson wolfberry, globemallow, and cheat grass are present.

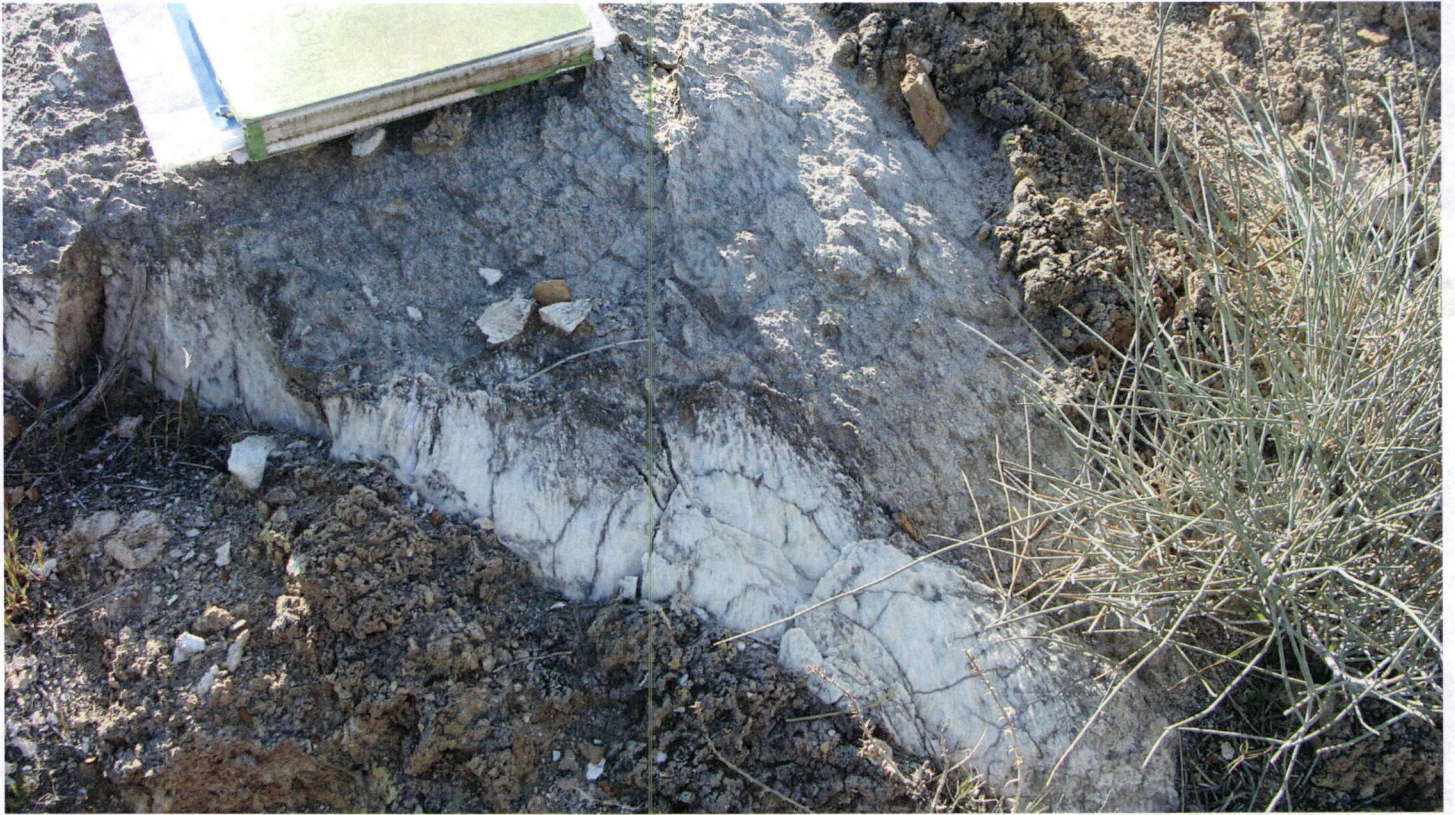
Close up of the exposed gypsum in the dozer trench.

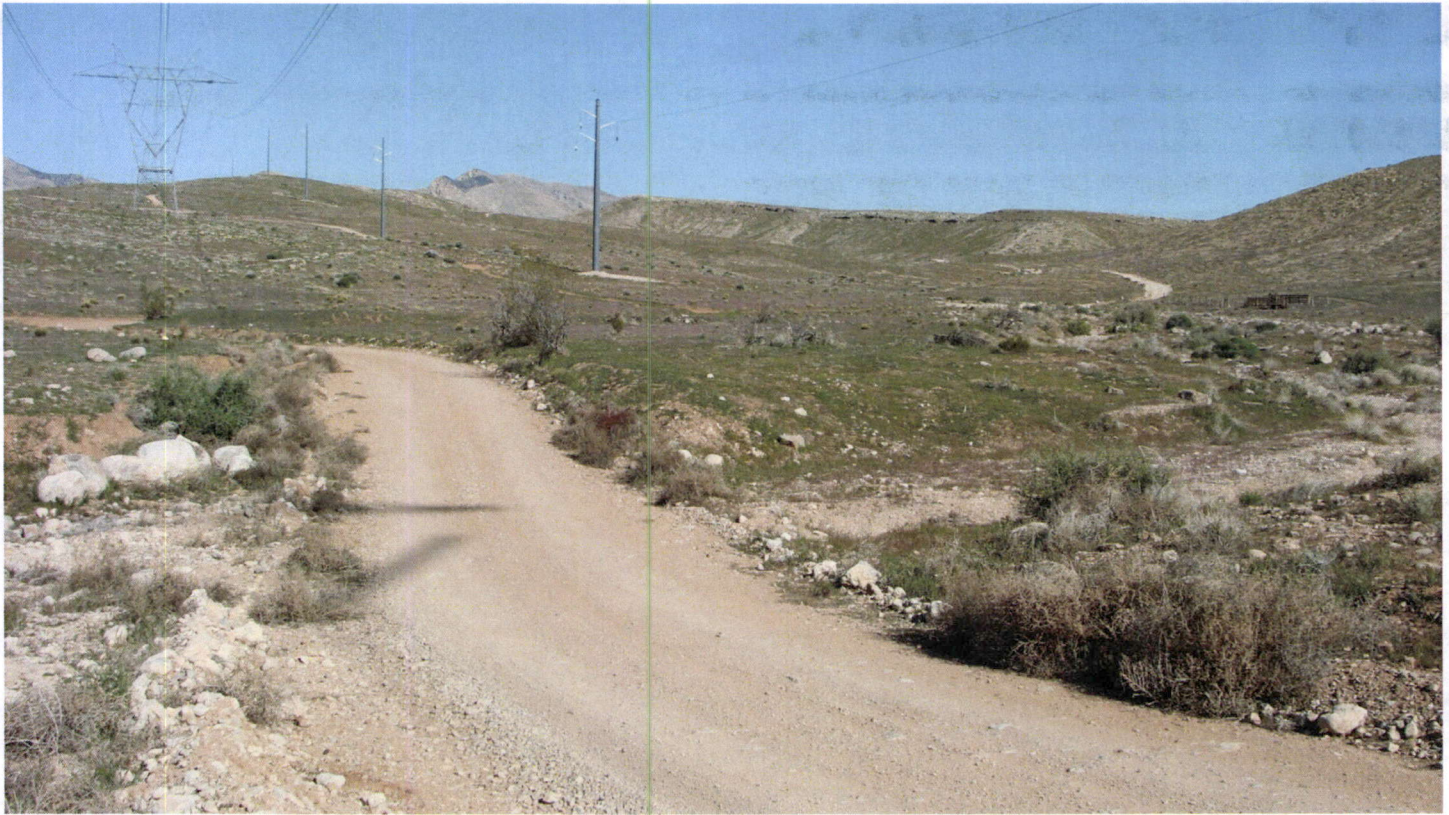
Comments: Pre-operation site inspection with Lynn Kunzler-UDOGM. No notice or plan was ever submitted for this area per LR-2000 records. The area was burned during the 2006 Jarvis fire. Vegetation consists of matchweed, Mormon tea, creosote bush, Anderson wolfberry, globemallow, and cheat grass. Gypsum section to be mined is approximately 50 ft thick. Footprint appears too small for stockpiling of top soil, impure material, and ore. Access road is too narrow (12 ft width average) to safely move the material in proposed haul trucks. Road needs to be widened or turnouts put in.

View of access road that averages about 12 ft wide at road junction and transmission line crossing in section 23 NE1/4 looking northwest.

Instructions to Operator: Rework plan of operations.
